**GEOLOGY 700 LANDSLIDES AND FLOODS
FIELD TRIP ROAD LOG**

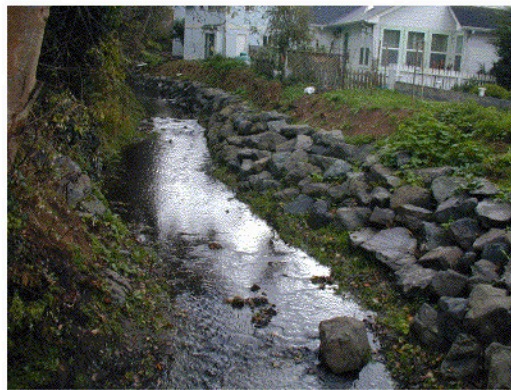
Ocean going ships once tied up to this pier in Port Kenyon, California. Now, the Salt River channel here is full of sediment and willows.

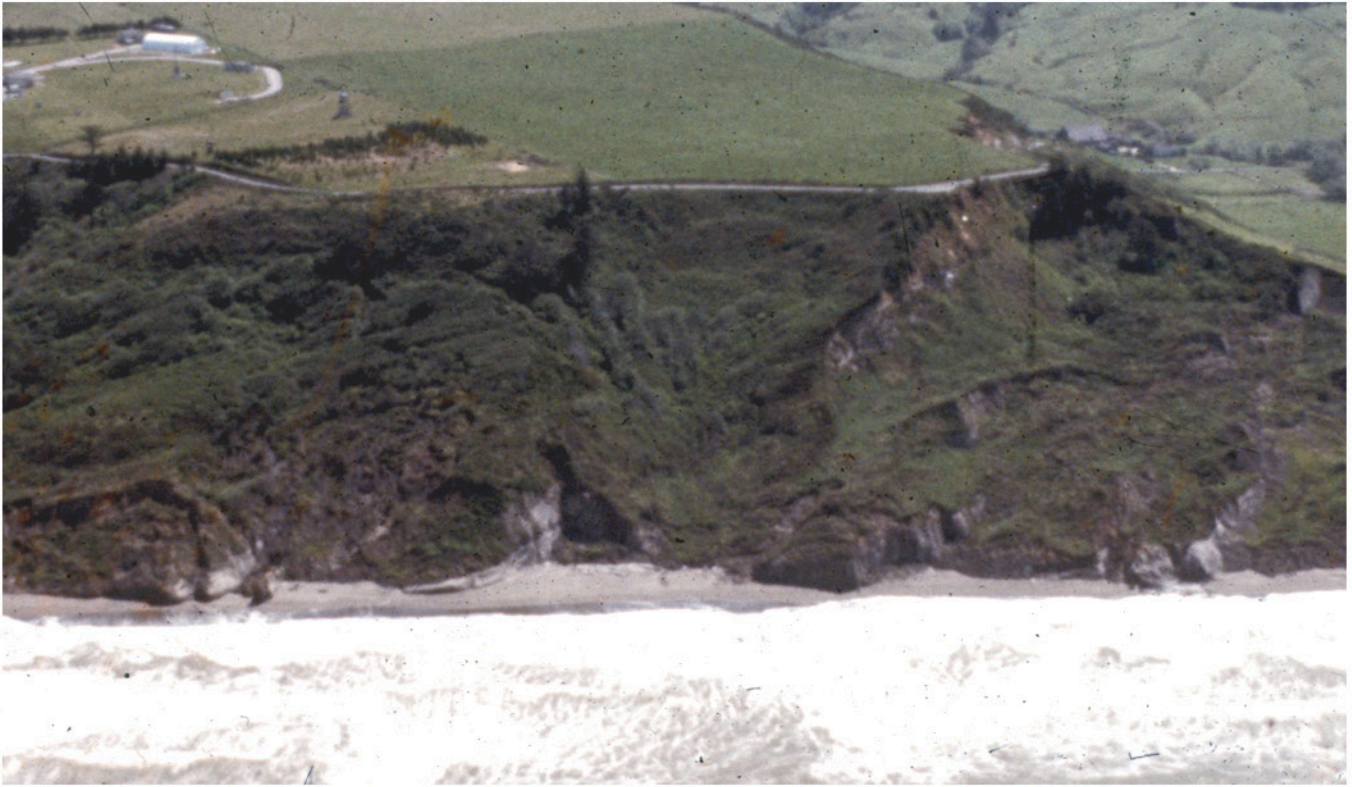
1972

CENTERVILLE BEACH LANDSLIDE

- 34.0 Centerville Beach Naval Station (abandoned)
- 34.3 **Stop 5:** Head of Centerville Beach landslide. This is a huge slump - debris slide/flow which occurred mostly in the winter of 1997-98. County road has been relocated several times to avoid growth of headscarp. Walk around and look at headscarp cracks, failure itself. Be careful of edges -- they are unstable and some overhang.

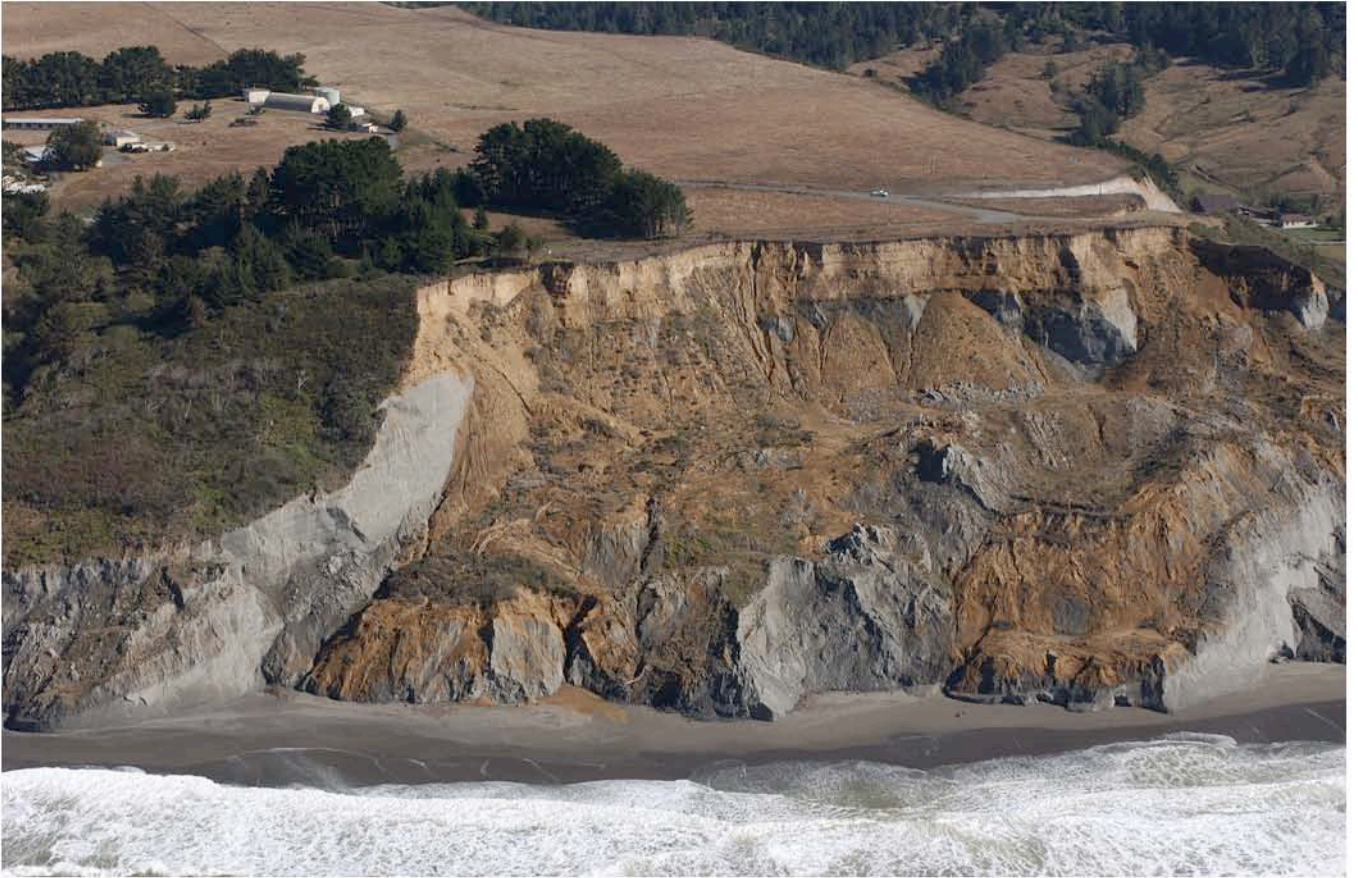
2005

CENTERVILLE BEACH LANDSLIDE

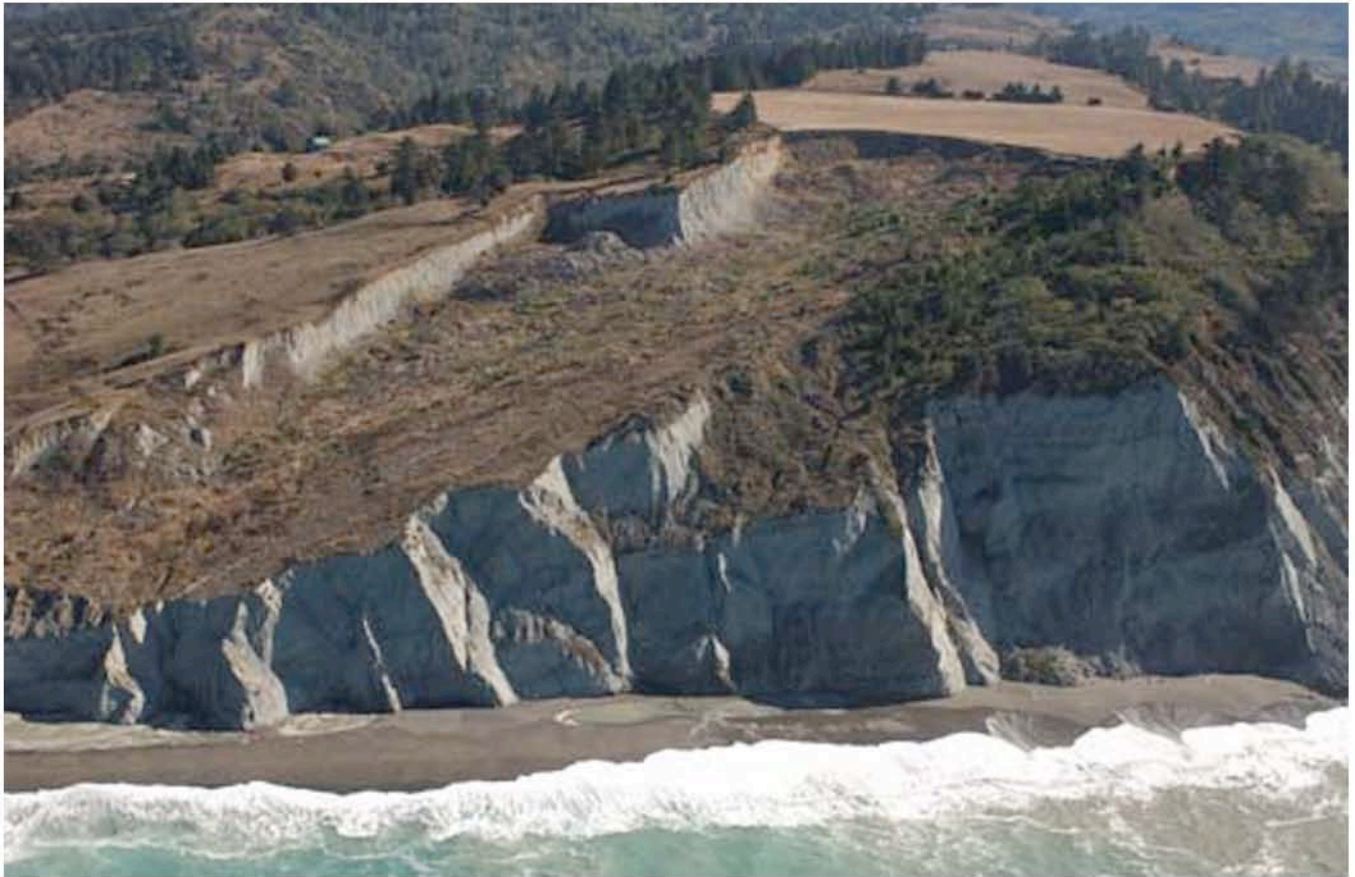
Fleener Cr Slide, 2002

- Walk to S margin of slide, look S toward valley of Fleener Cr. Upstream you can see debris slides. Directly S lumpy topography marks old earthflow. Slides were reactivated here in 1997 (note large grey scarp).

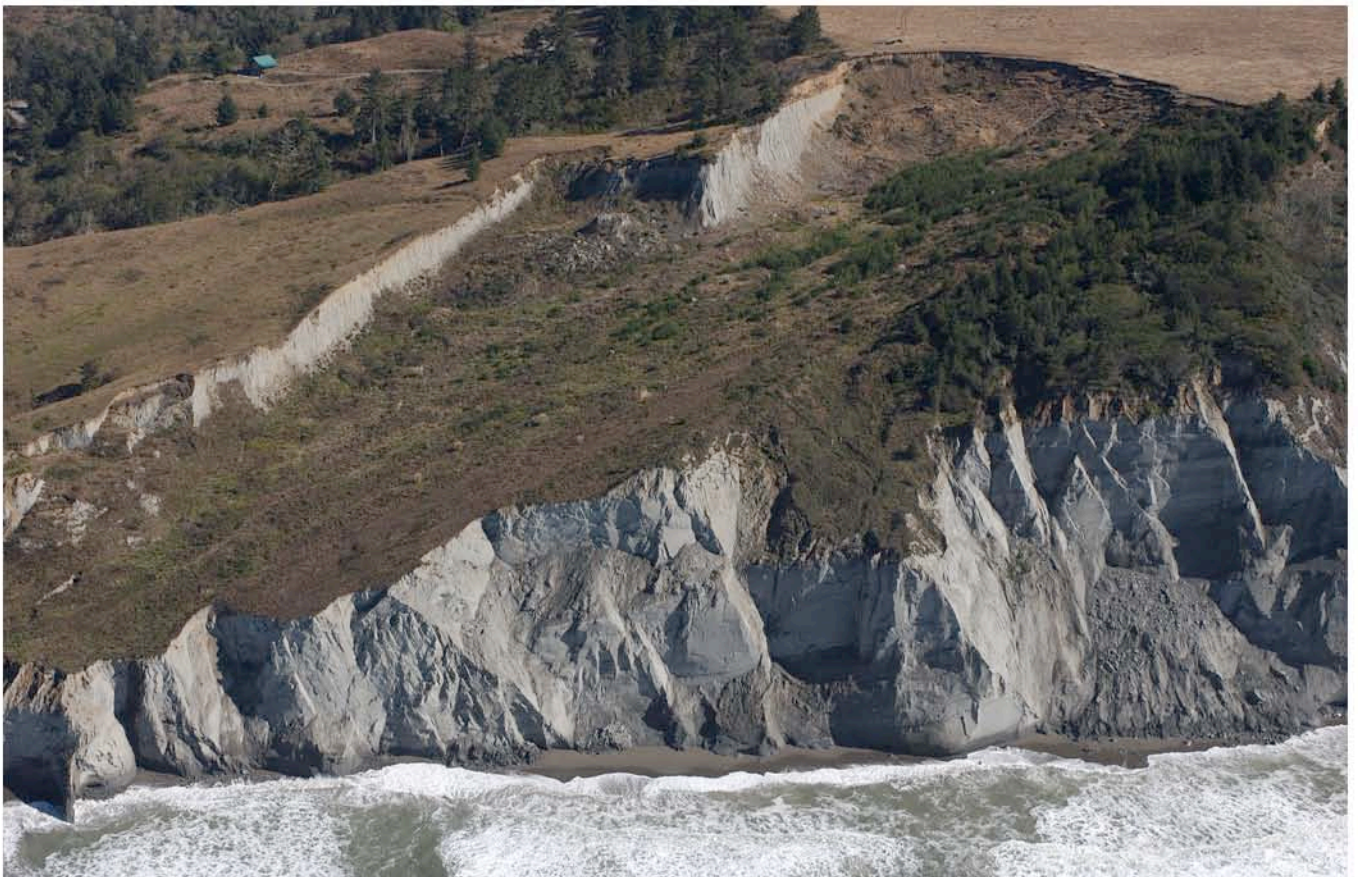
Fleener Cr Slide, 2005

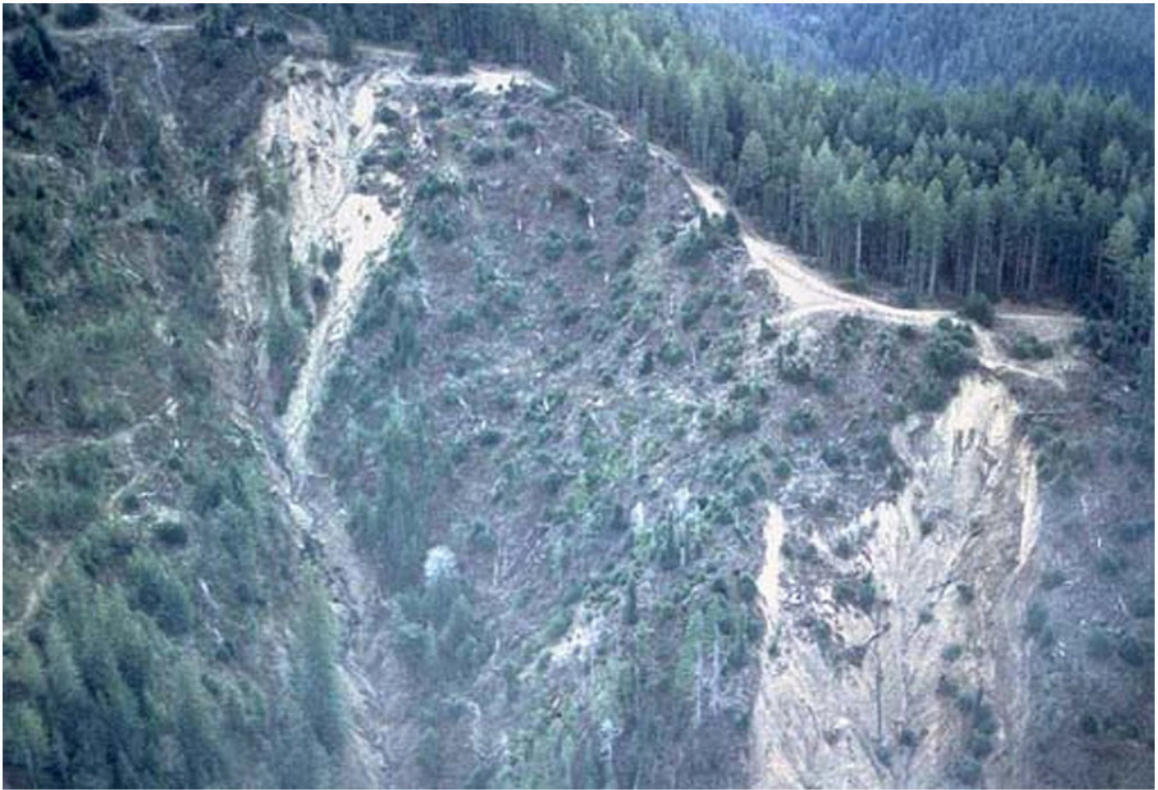
Source area of Stafford debris torrent

- Stafford is on a terrace of the Eel R. It was severely damaged by the 1964 floods. In winter 1996-97, a major debris torrent devastated Stafford. The debris torrent originated from a large debris slide or flow on logged land upslope. The slide, originating in a hillslope hollow, landed in the stream channel and, mixing with the streamflow became a highly mobile debris torrent. When the torrent hit Stafford Flat it spread out, engulfing and destroying several houses.

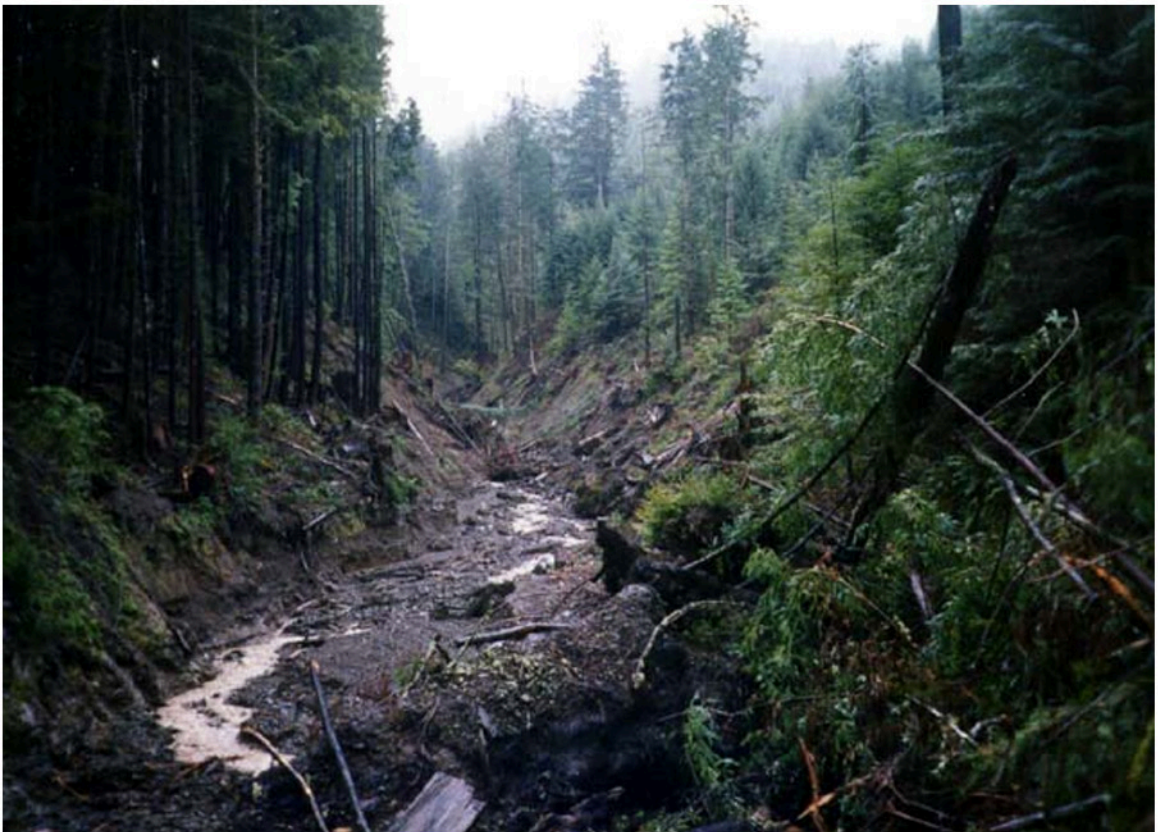
Effects of debris torrent on channel

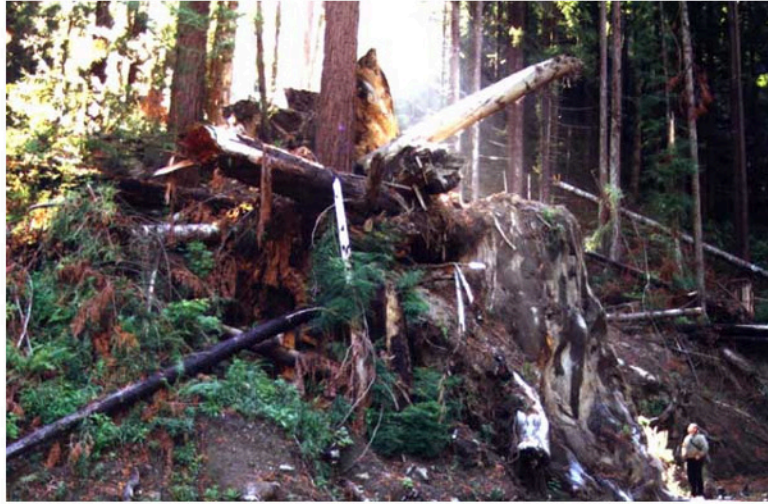
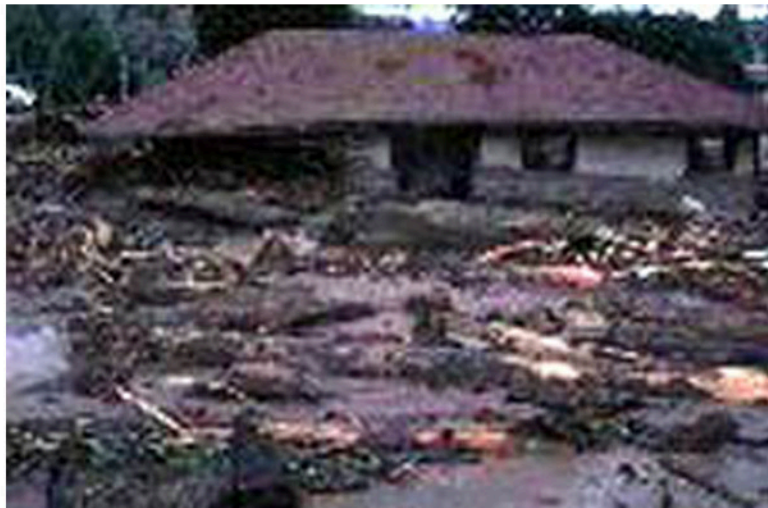
Stafford Debris Torrent Effects

perspective diagram showing
source drainage for Stafford slide
green areas are SHALSTAB slide
area predictions

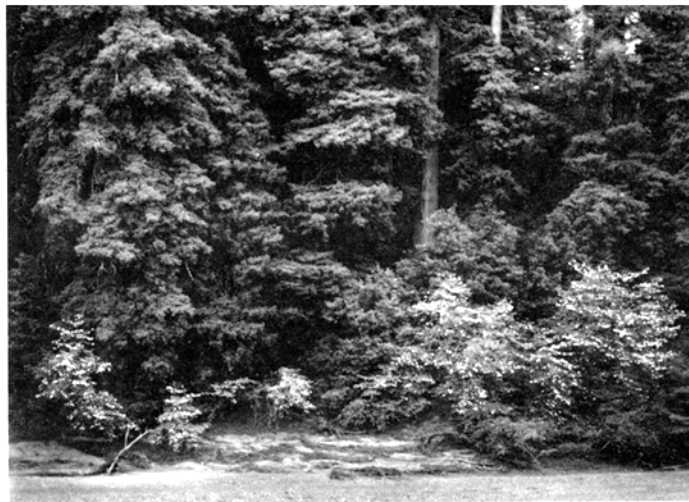
1947

Bull Creek channel, before and after sediment input

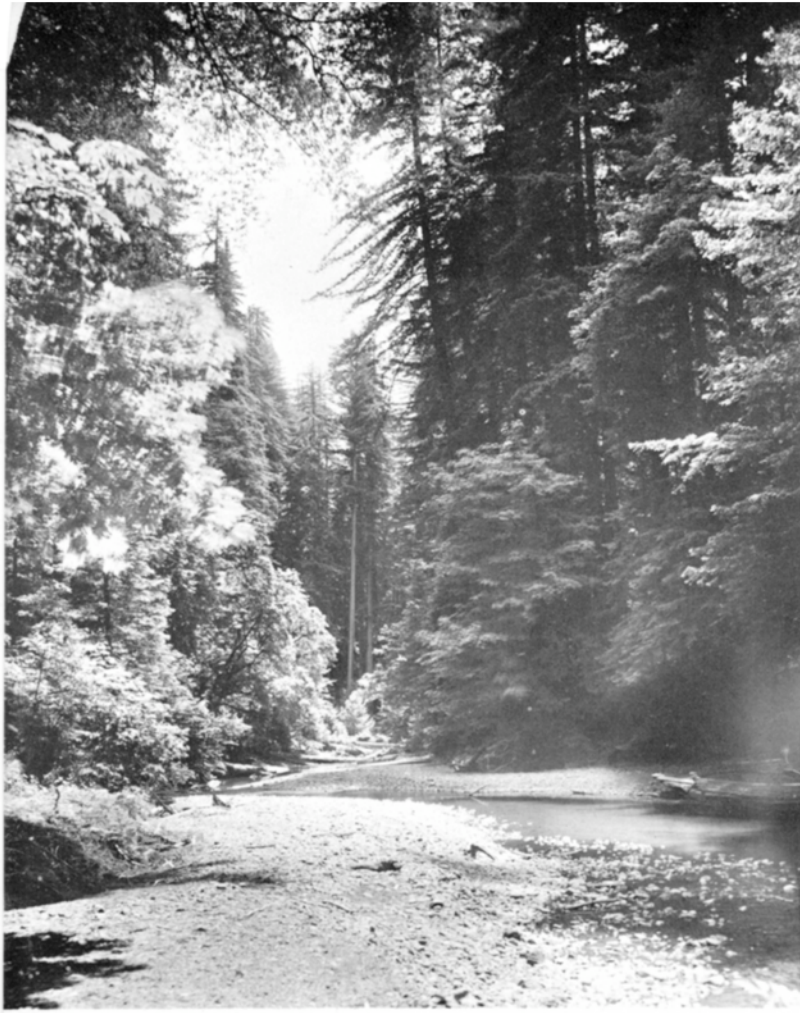
Channel of Bull Creek before logging in upper watershed. Average width no more than 60 ft.

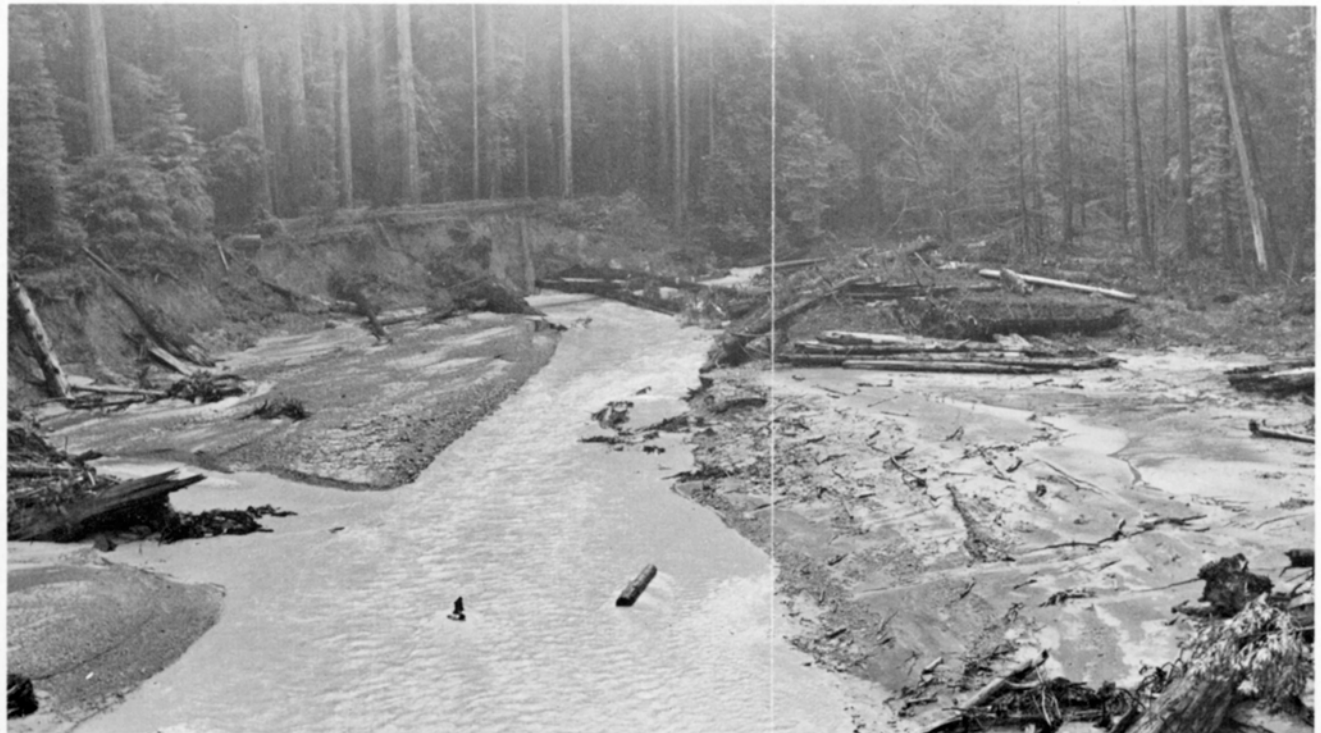
Channel of Bull Cr circa 1960. Width about 300 ft.

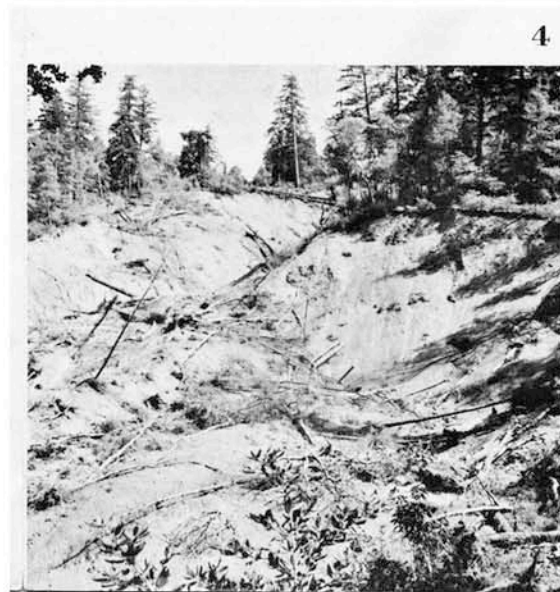
Large landslide in Bull Cr watershed, circa 1960.
Possibly the beginning of the Devil's Elbow slide?

- Continue uphill along Mattole Road.
- 82.0 **Stop 10:** Devil's Elbow Slide viewpoint. This huge debris slide complex was initiated in the storms of 1955 after logging and fire. Previously it was simply a forested slope. The slide enlarged further in 1964, and has continued to grow and gully. Its headward growth has caused relocation of the Mattole (Honeydew) Road. This slide complex is a major contributor of sediment to Cuneo Cr.

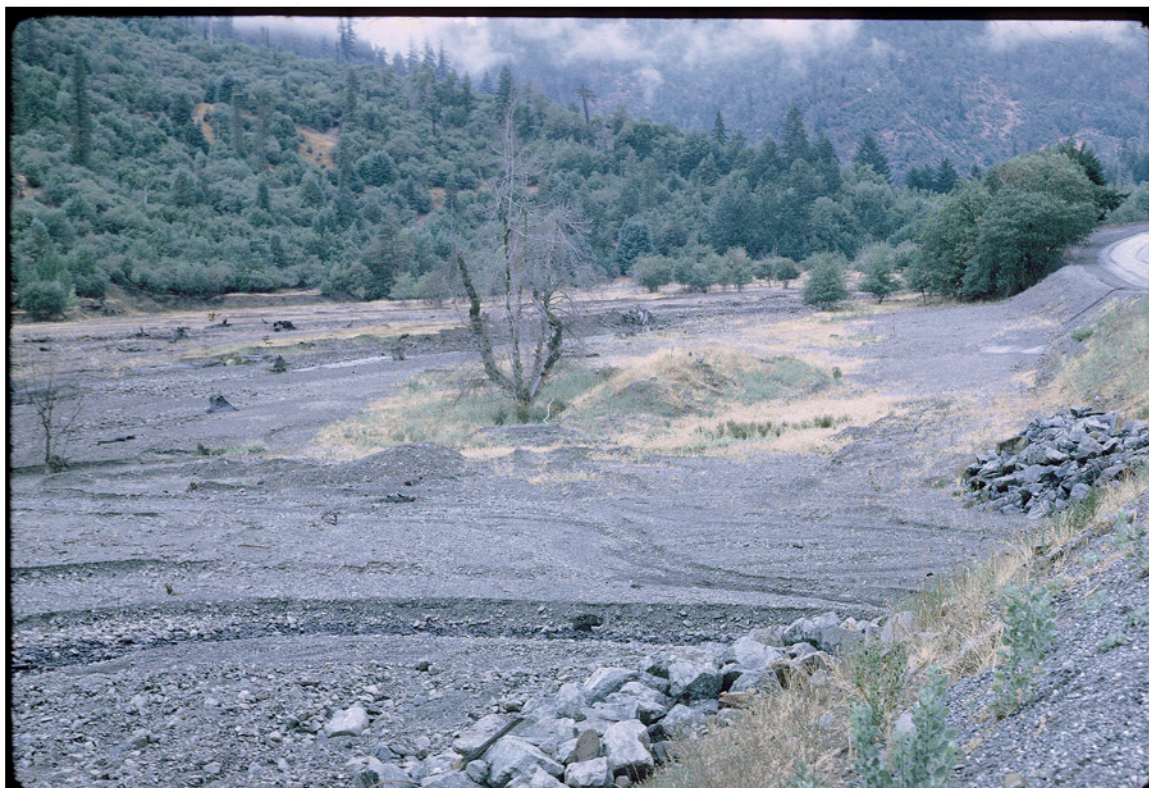
**View upstream along Bull Cr from junction with Cuneo Cr.
August 1968**

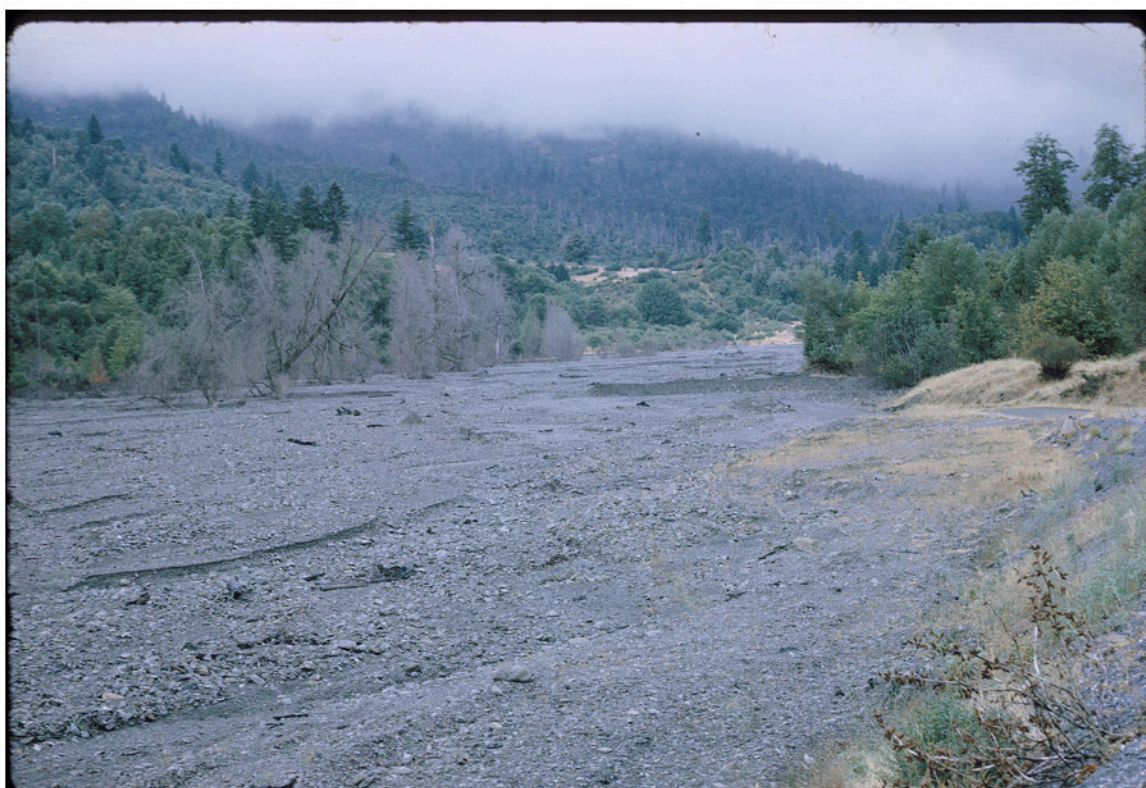
**View up Cuneo Cr. from its junction with Bull Cr. Slide taken
from the road at N end of the bridge. August 1968**

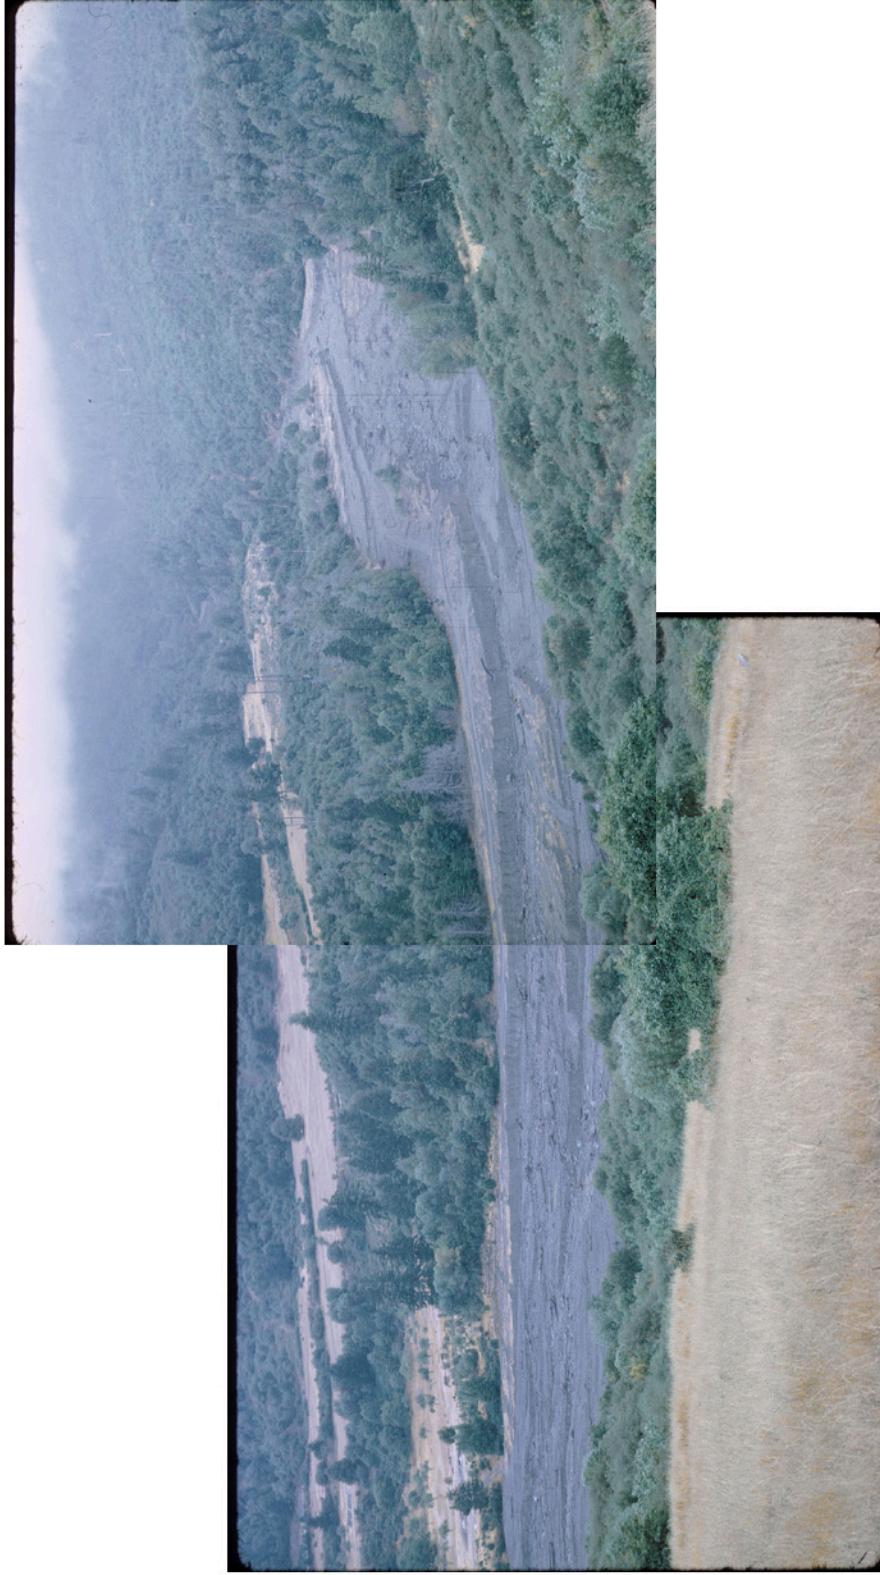
View up Cuneo Cr from Pole Line Road, August 1968
Photos taken by A.K. Lehre

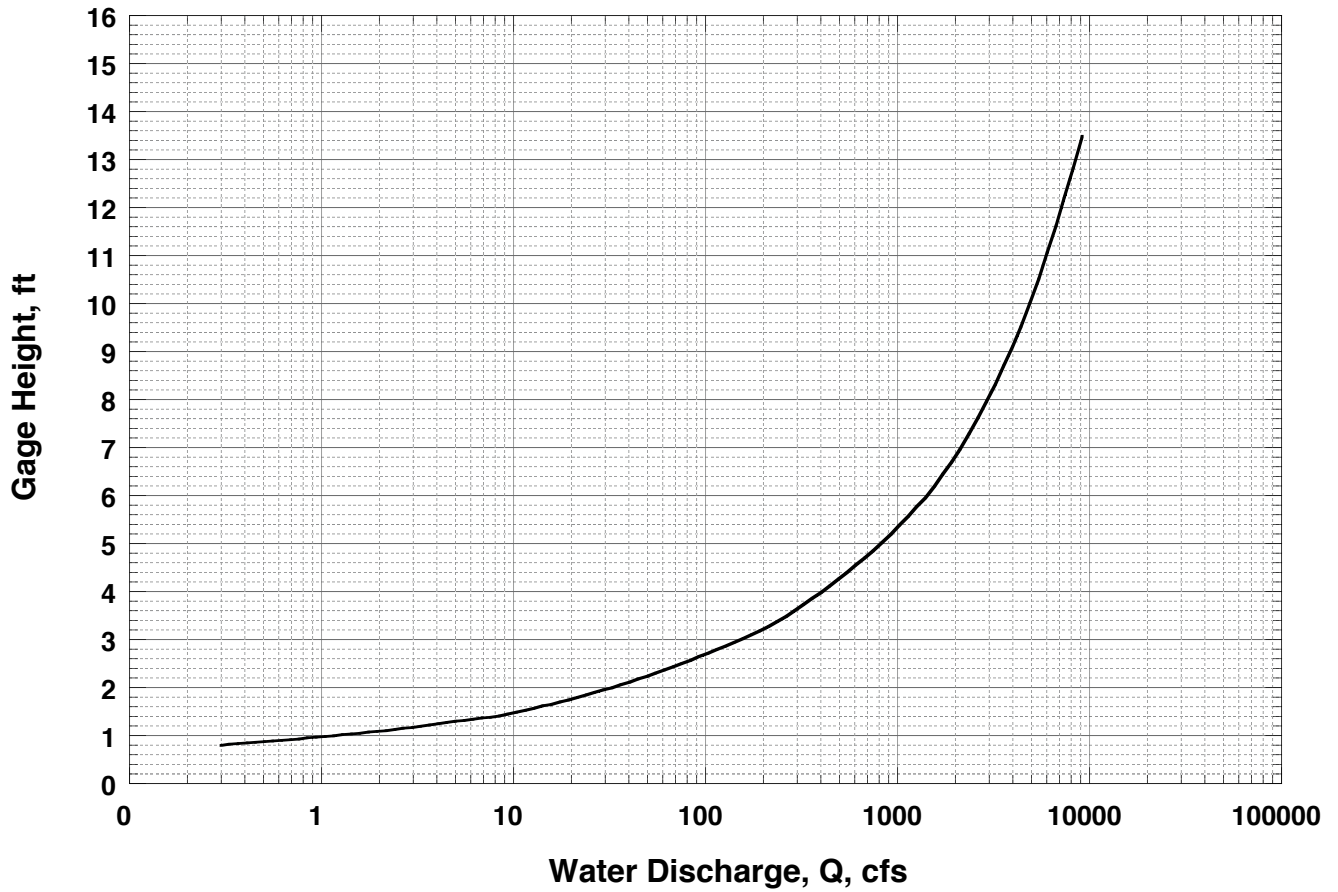
Bull Creek Rating Curve
 Drainage Area 28.1 sq mi
 USGS rating relation as of 09-13-06

- 87.9 **Stop 14:** Bull Cr. bridge and gaging station. Look at gaging station, bankfull indicators. Discuss stream gaging. The drainage area of Bull Cr. here is 29.1 sq. mi.

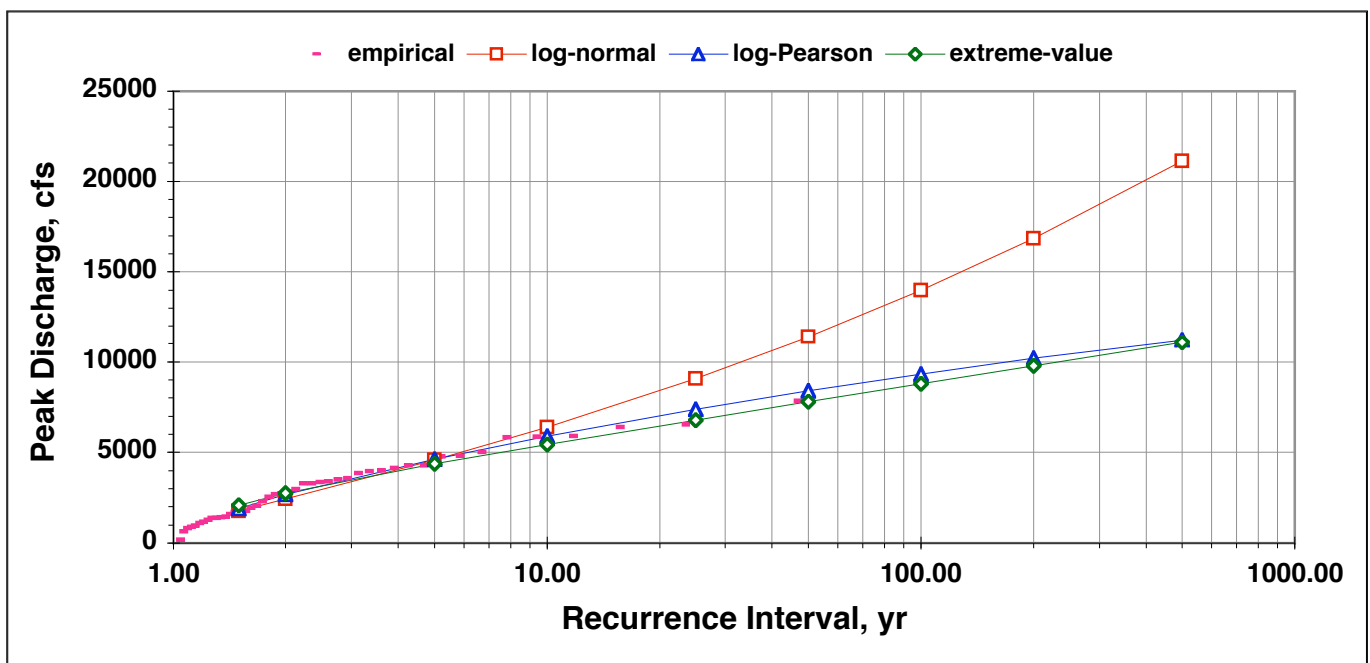
Flood-Frequency Curves for Bull Creek
 1961-2005
 Drainage Area 28.1 sq. mi.
